**APPLICATION FOR HERITAGE GRANTS FUNDING ASSISTANCE FALL 2017**

**HISTORIC PROPERTY AND ADDRESS:** 708 San Antonio, Austin, Texas 78701

**APPLICANT'S NAME:** Austin Woman's Club

**PROJECT NAME:** Windows Restoration of North-Evans Chateau Fall 2017

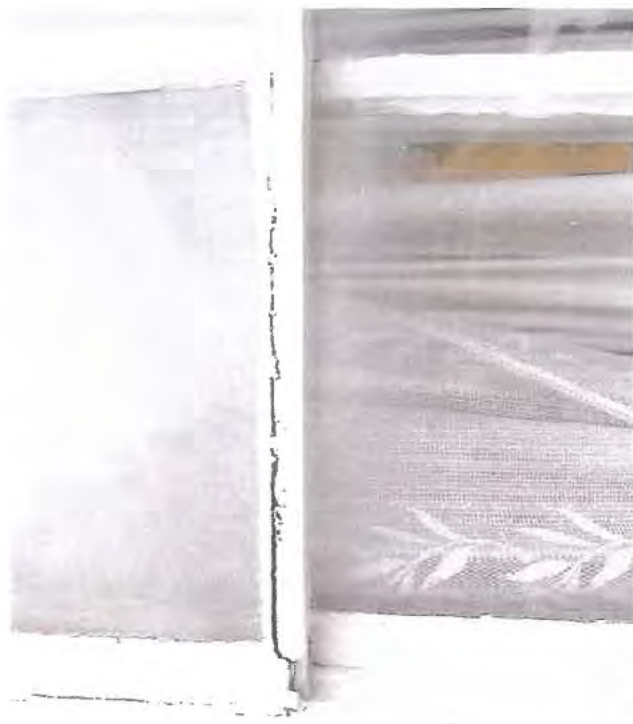
Photo 8: Deteriorated glazing putty has caused rail/stile joint to fail at this window. Note deteriorated paint on frame.

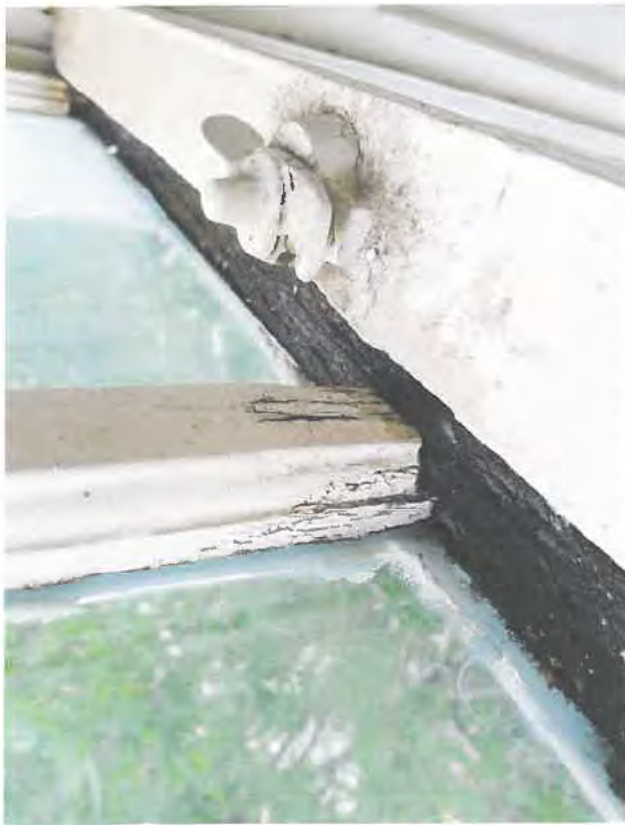
Photo 9: Deteriorated glazing putty has caused the bottom rail of the top sash to rot. Rail is dropping and bottom of muntin is rotting. Rails no longer meet and keeper of original sash lock is missing.

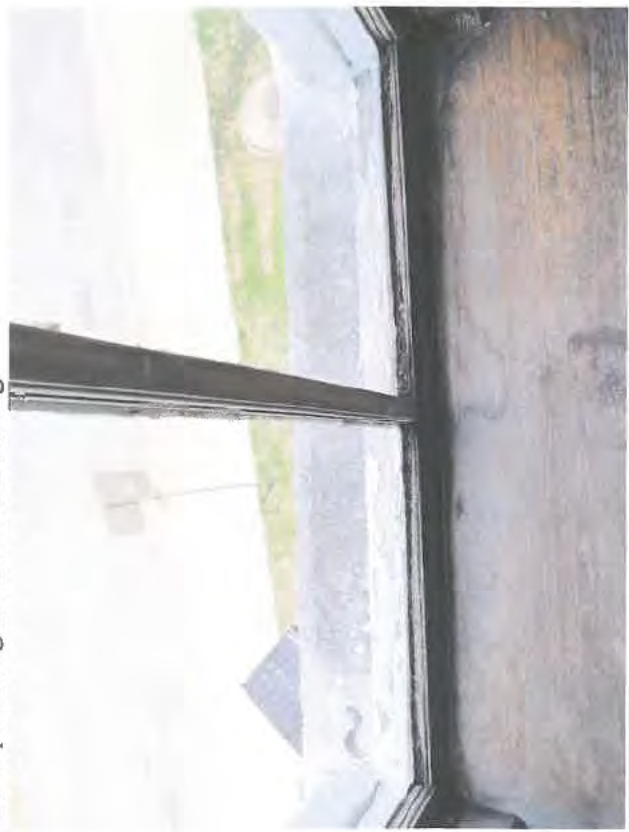
Photo 11: Typical sill condition. Note peeling paint and exposed wood. Note deteriorated finish on interior stool and water stains.

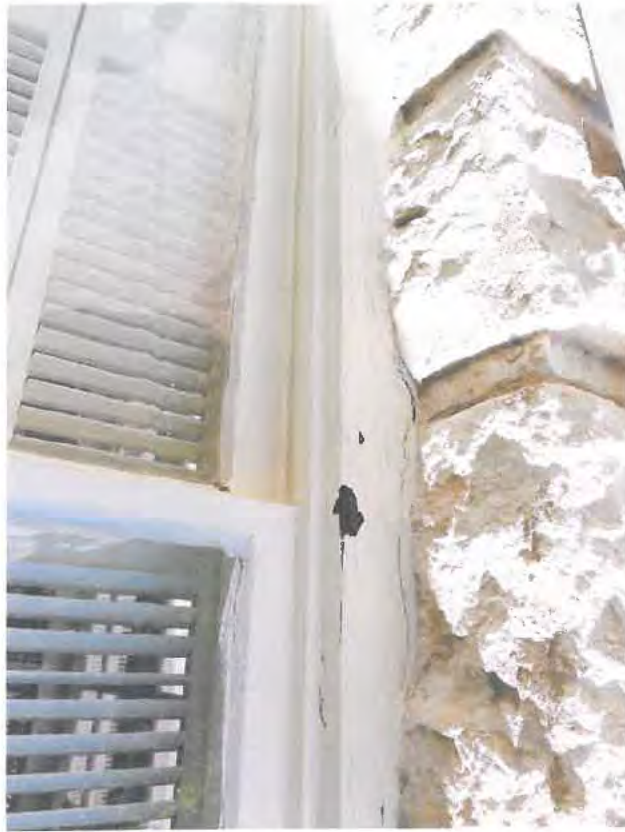
Photo 10: Jamb in contact with stone is rotting. Note open sealant joint.

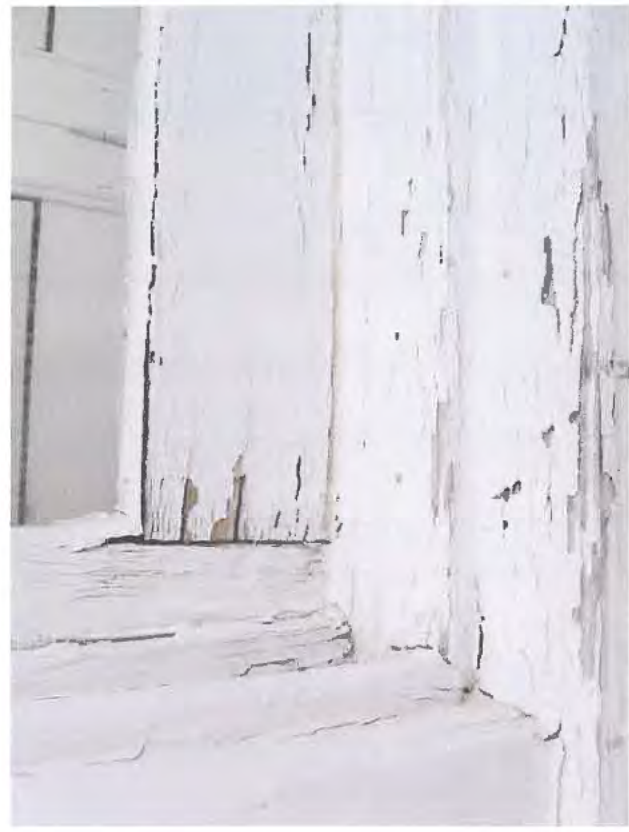
Photo 12: Detail of typical exterior sill conditions. Note peeling paint and open joints. Note failing glazing putty on sash, checked bottom rail, and failing stile/rail joint.

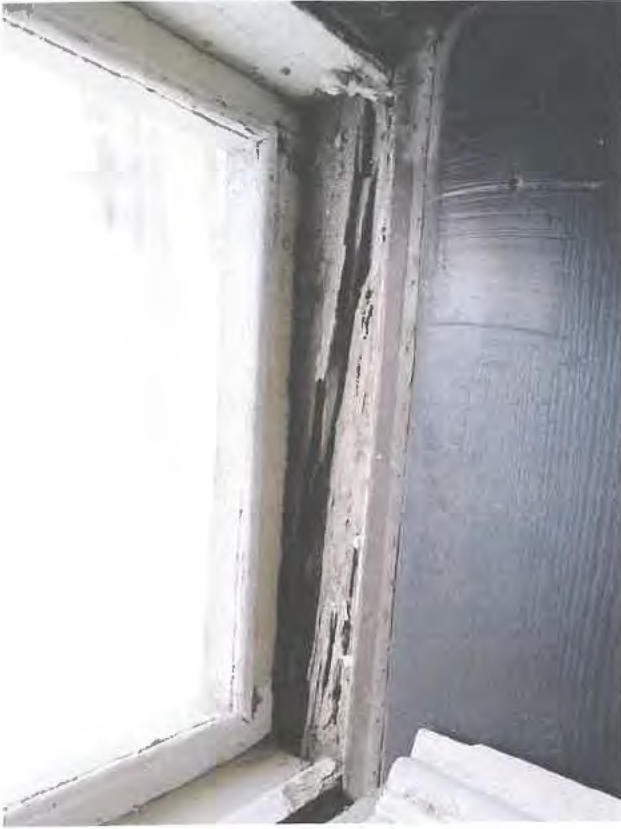
Photo 14: Termite damaged window sill.

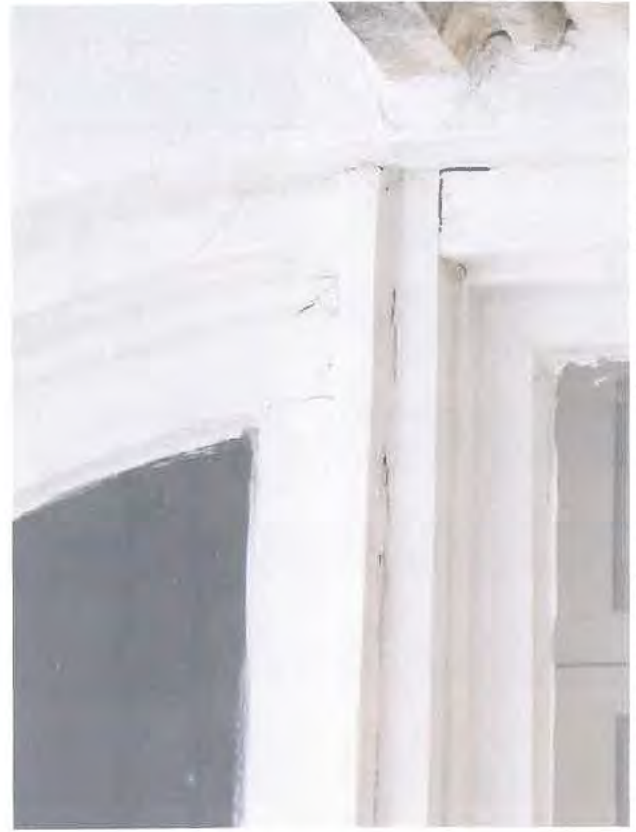
Photo 16: Typical window transom conditions. Note failing paint, open joints, deteriorated glazing putty, and rotting trim.

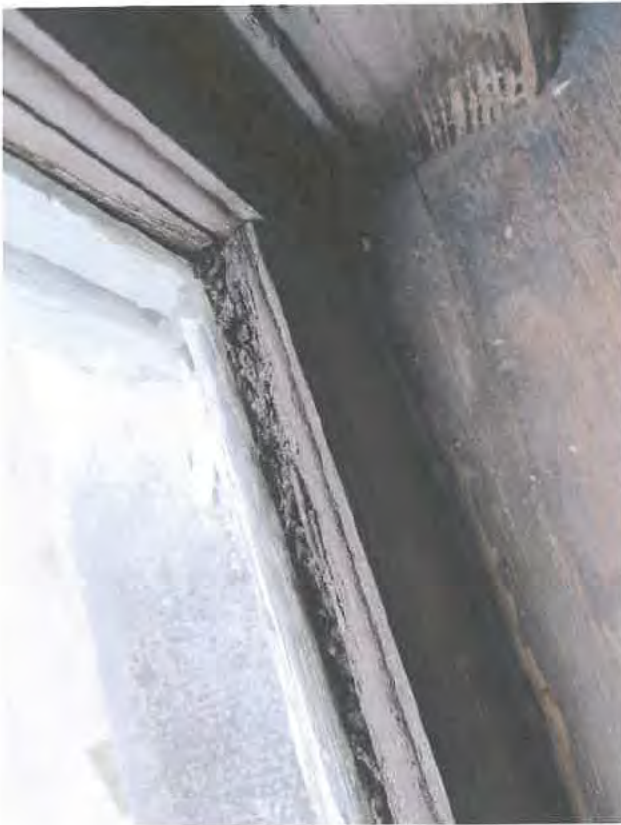
Photo 13: Detail of rotting bottom rail of bottom sash. Note deteriorated finish on interior stool and jamb.

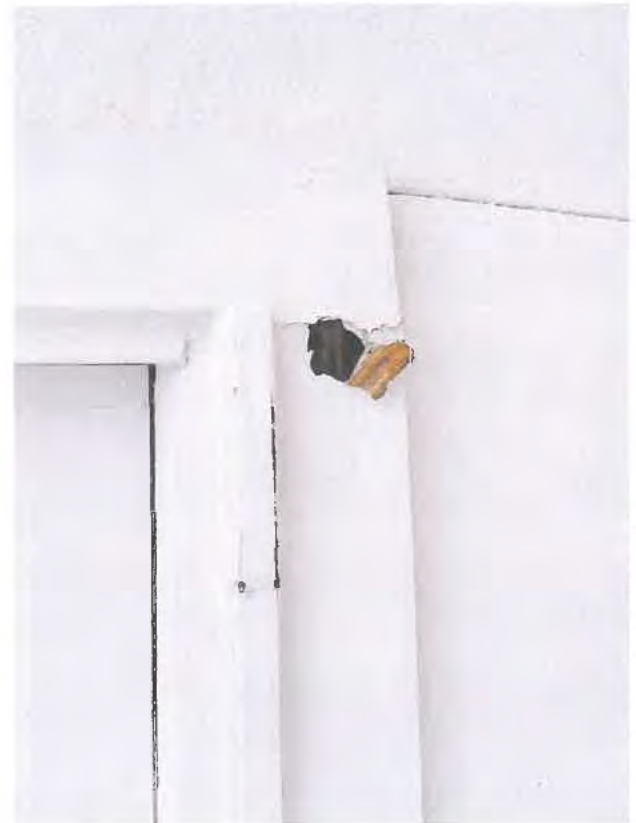
Photo 15: Rotting window trim.

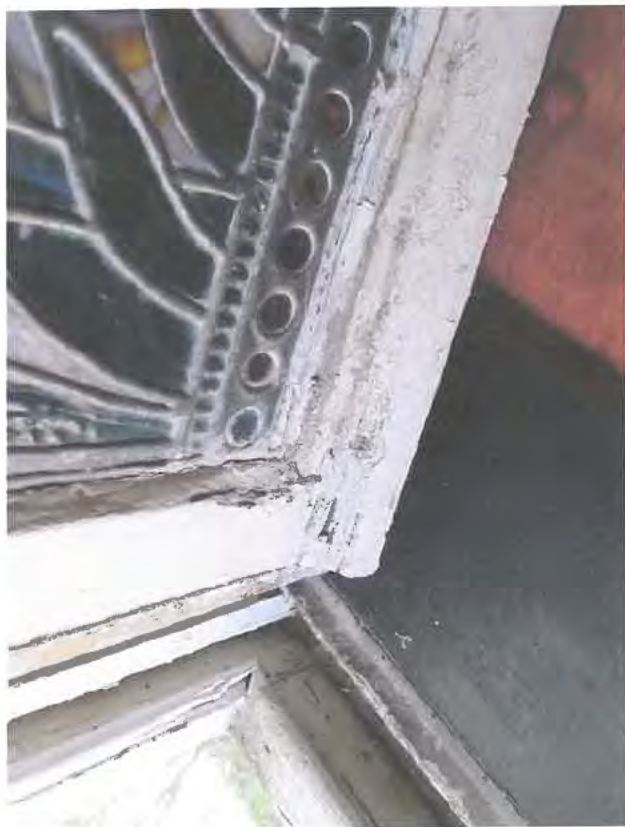
Photo 17: Typical condition of casement sash with stained glass. Note failing glazing putty and deteriorating stile/rail joint.

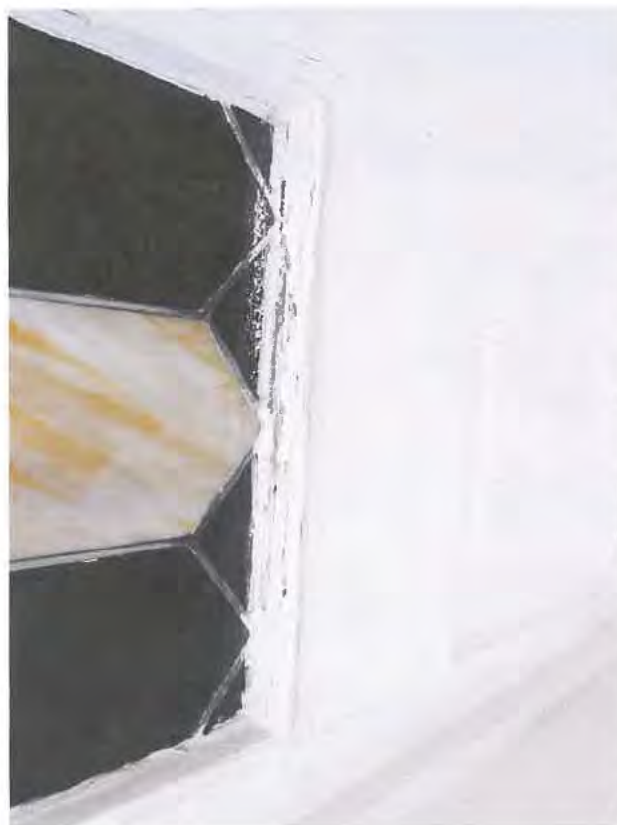
Photo 19: Typical door sidelight. Note deteriorated glass stop, peeling paint, checked wood, and water stains. Glass does not meet safety glazing requirements of the building code.

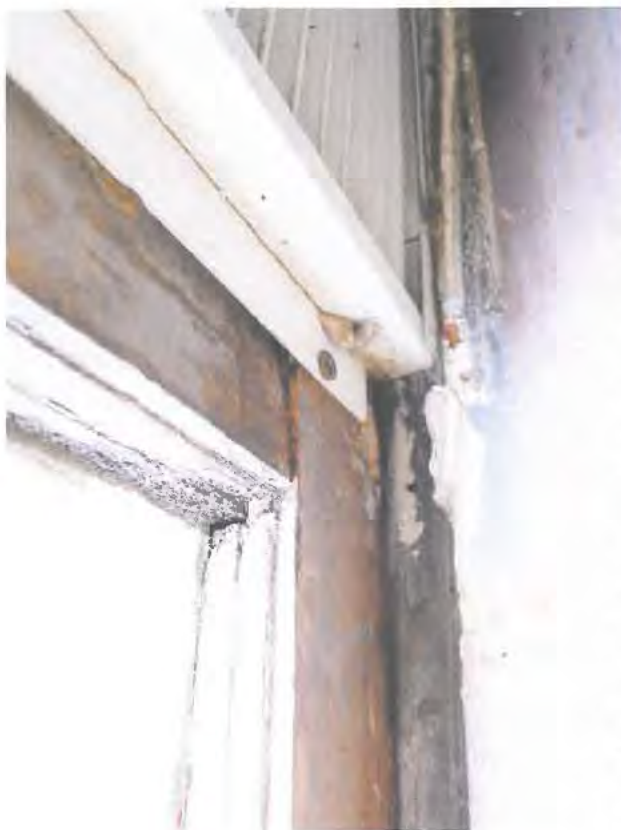
Photo 18: Typical damage caused by window air conditioning units. Note displacement of sash. This air conditioning unit is held in place only by the window sash. The bottom rail of the sash is rotting due to failed putty.

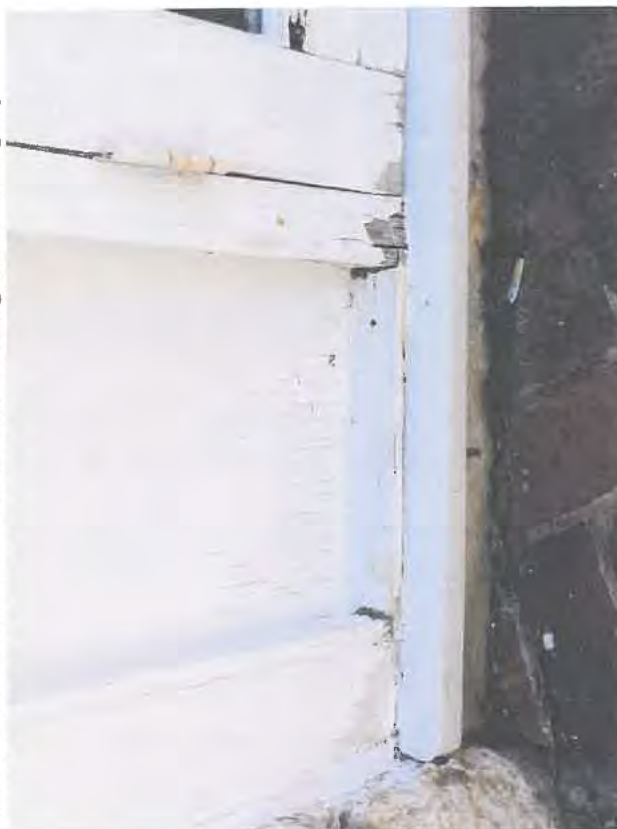
Photo 20: Sill at door sidelight. Note open joints, peeling paint, checked and rotting wood, and rust stains from corroding metal.

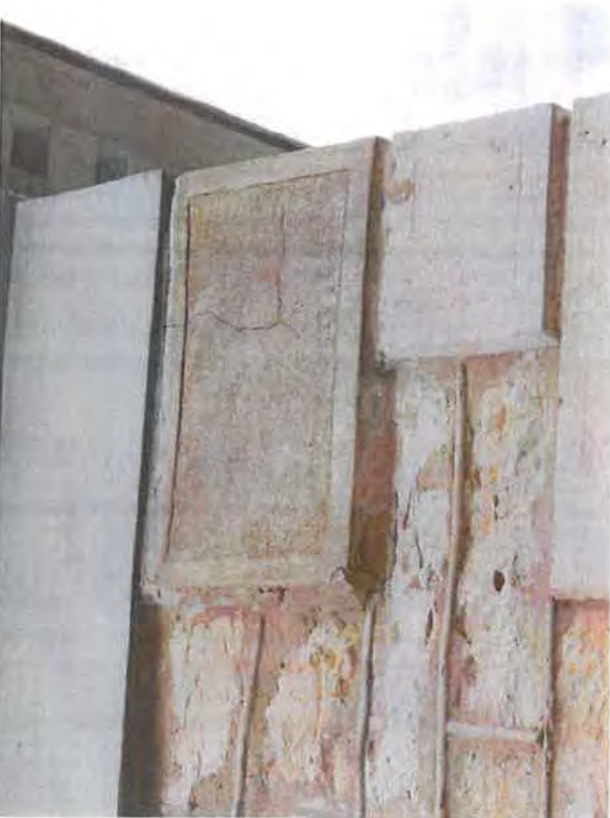
Photo 1: Cracked mortar quoin at southwest corner of main building, west elevation.

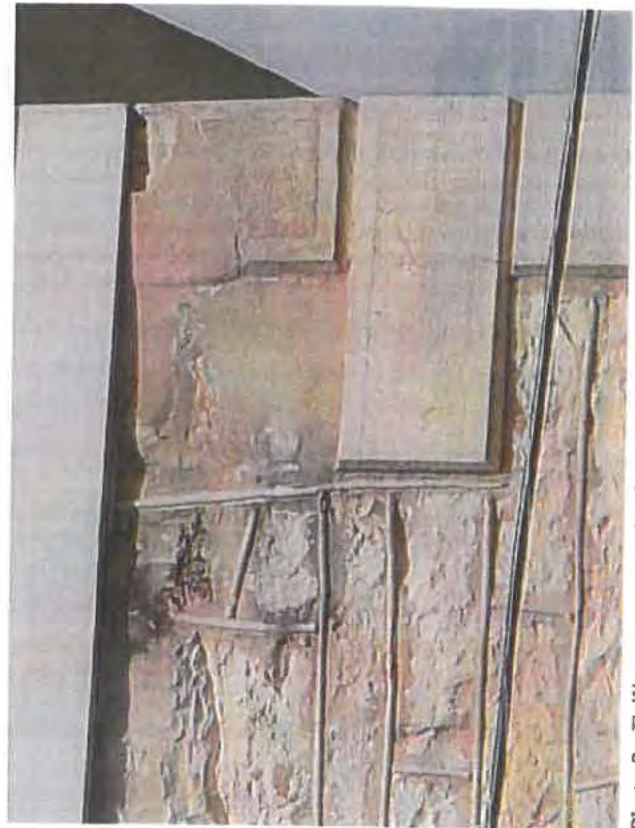
Photo 3: Failing mortar patch of quoin at northeast corner of main building, east elevation.

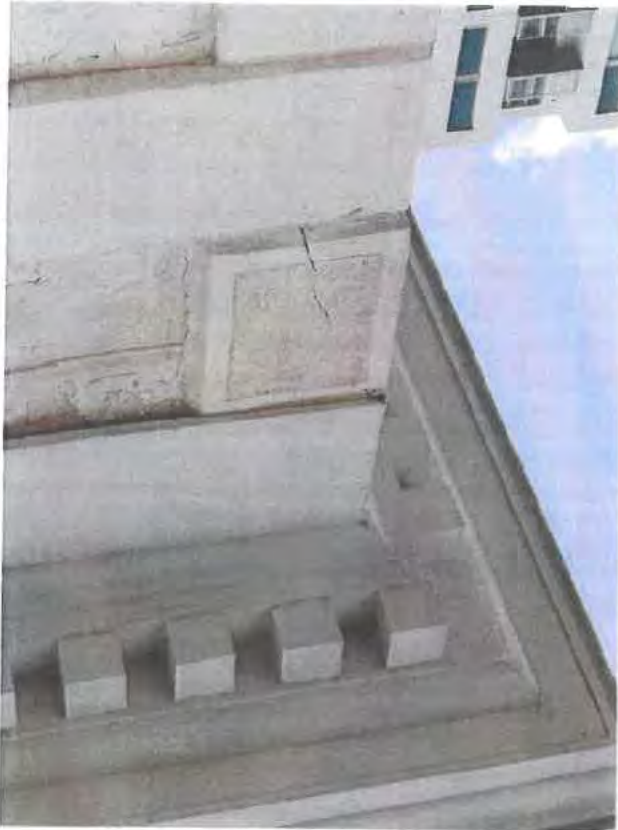
Photo 2: Cracked mortar quoin at southwest corner of main building, south elevation.

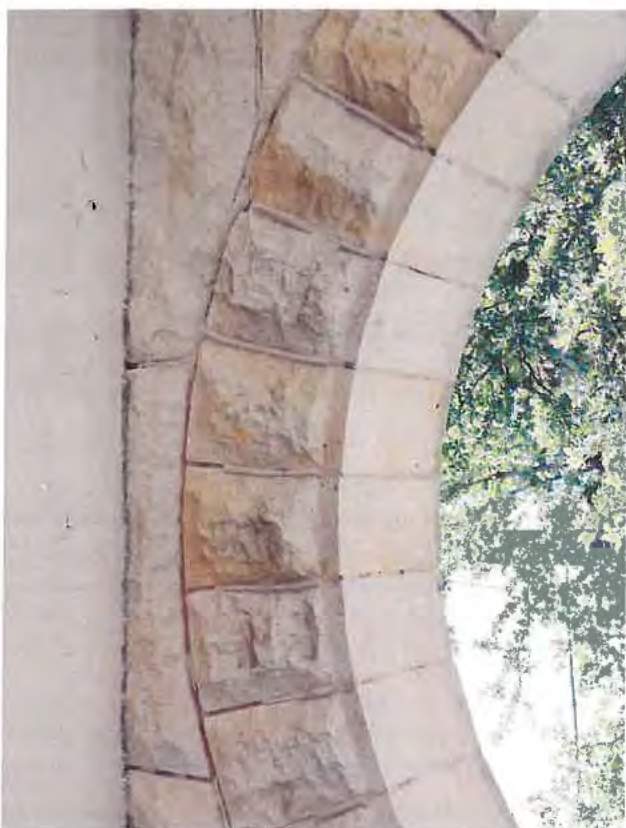
Photo 5: Eroded/cracked mortar joints at east arch of ground floor south portico.

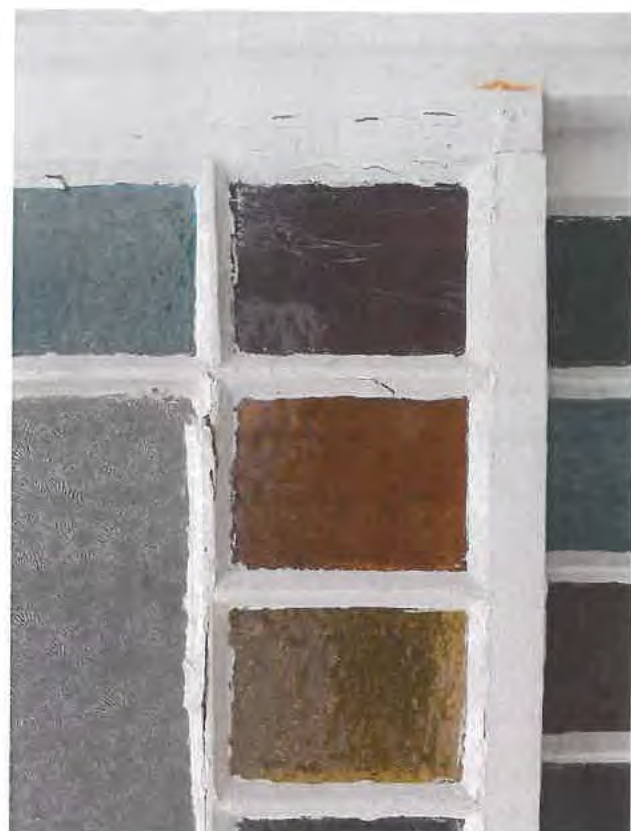
Photo 6: Deteriorated glazing putty and paint is typical. Note dropping bottom rail and stain from rusting fastener.

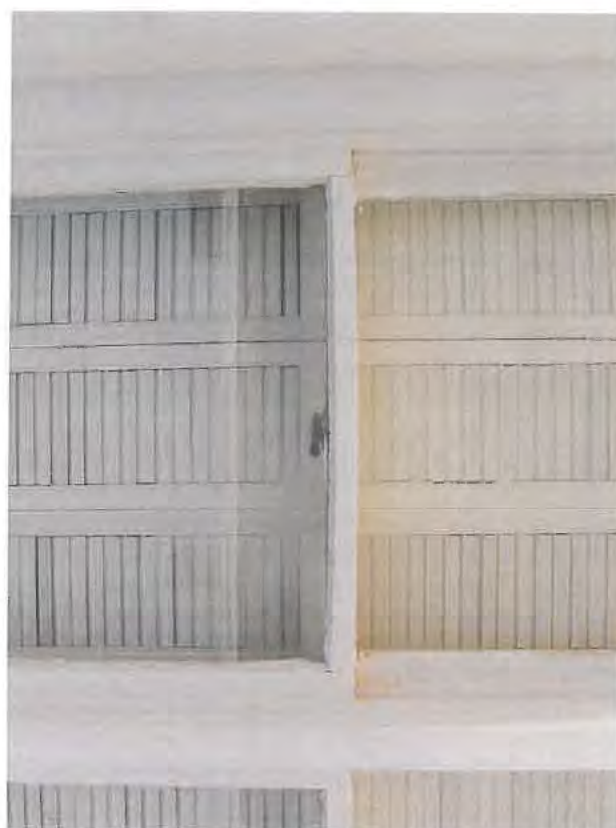
Photo 7: Typical example of failing bottom rail of top sash. Rail is bowing and dropping.

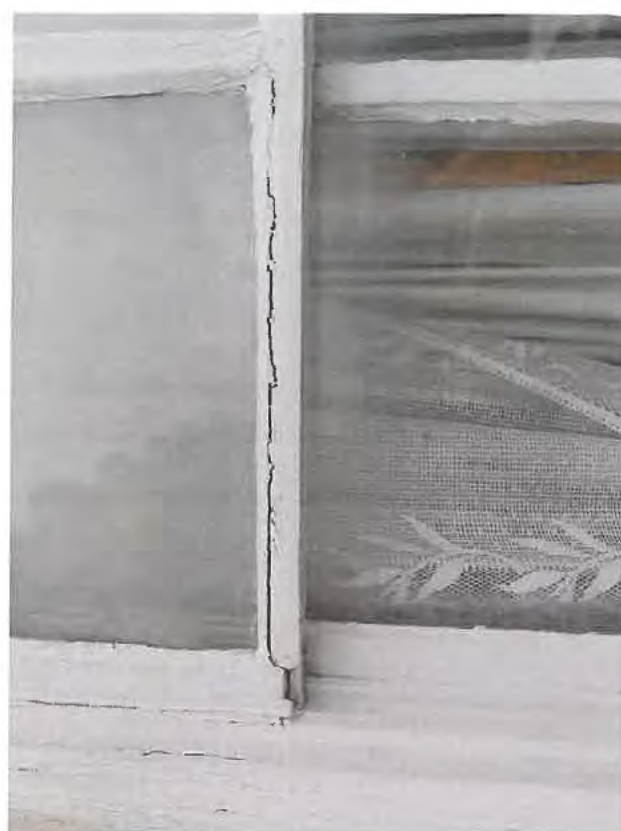
Photo 8: Deteriorated glazing putty has caused rail/stile joint to fail at this window. Note deteriorated paint on frame.

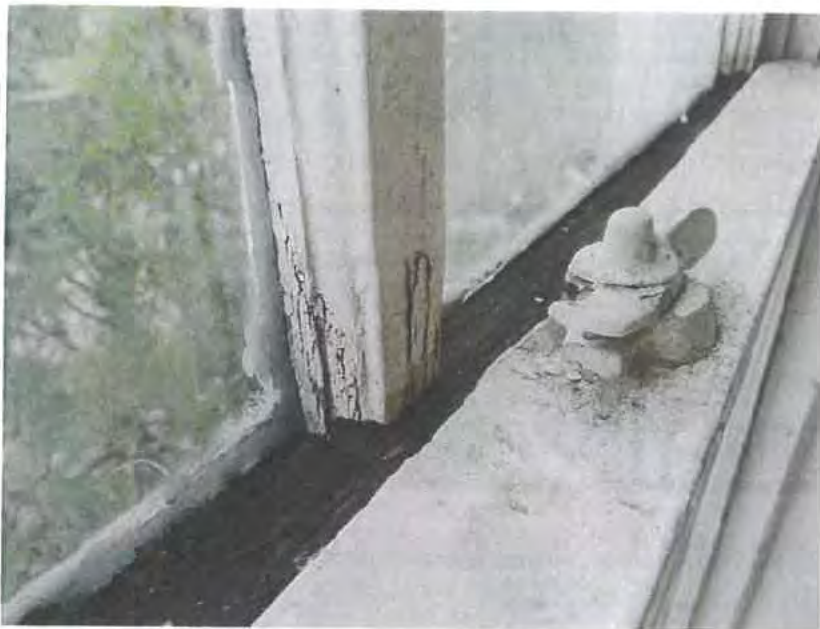
Photo 9: Deteriorated glazing putty has caused the bottom rail of the top sash to rot. Rail is dropping and bottom of muntin is rotting. Rails no longer meet and keeper of original sash lock is missing.

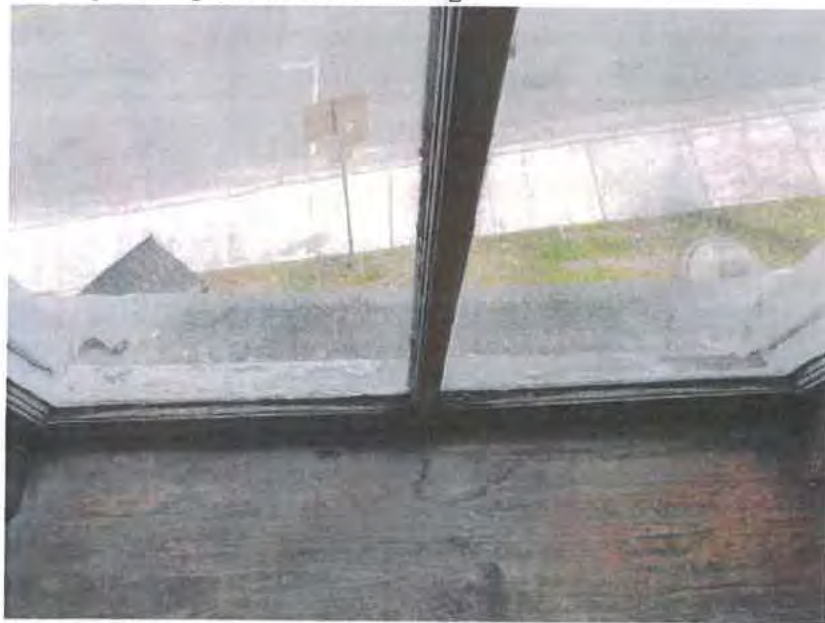
Photo 11: Typical sill condition. Note peeling paint and exposed wood. Note deteriorated finish on interior stool and water stains.

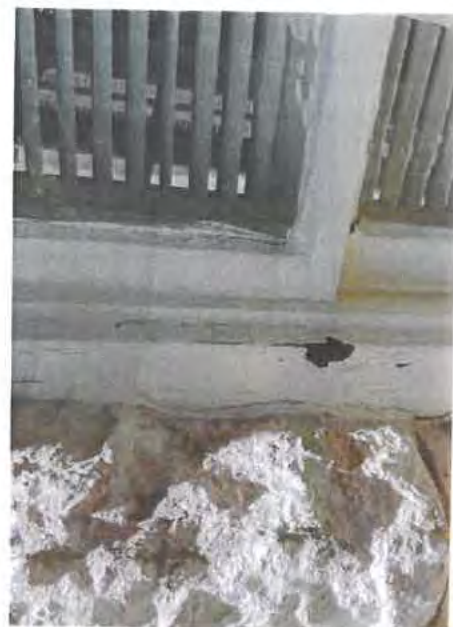
Photo 10: Jamb in contact with stone is rotting.

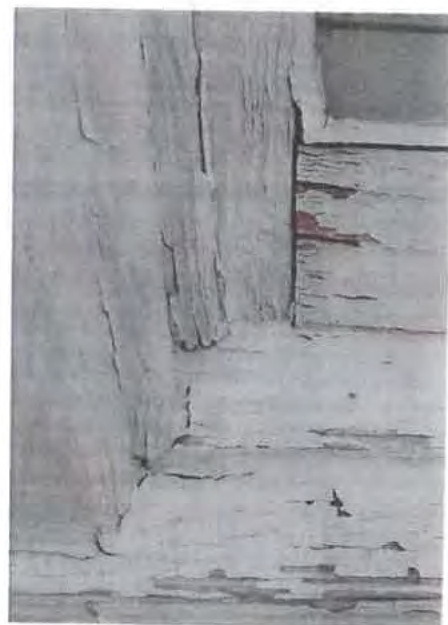
Photo 12: Detail of typical exterior sill condition. Note open joints. Note failing glazing putty or failing stile/rail joint.

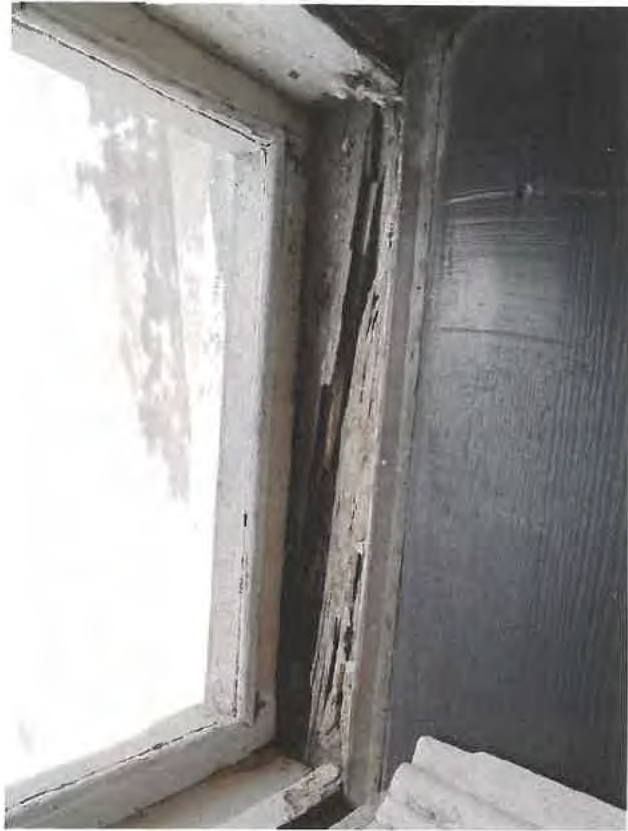
Photo 14: Termite damaged window sill.

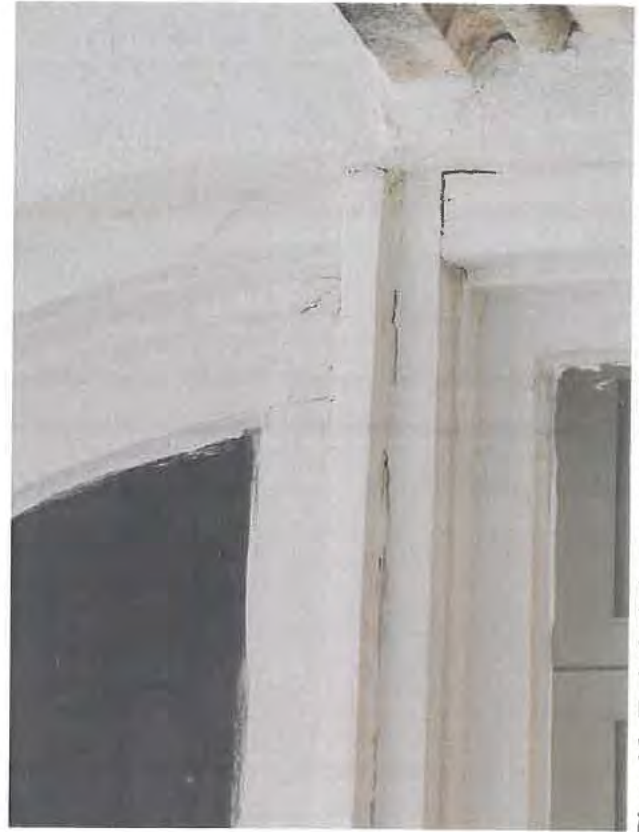
Photo 16: Typical window transom conditions. Note failing paint, open joints, deteriorated glazing putty, and rotting trim.

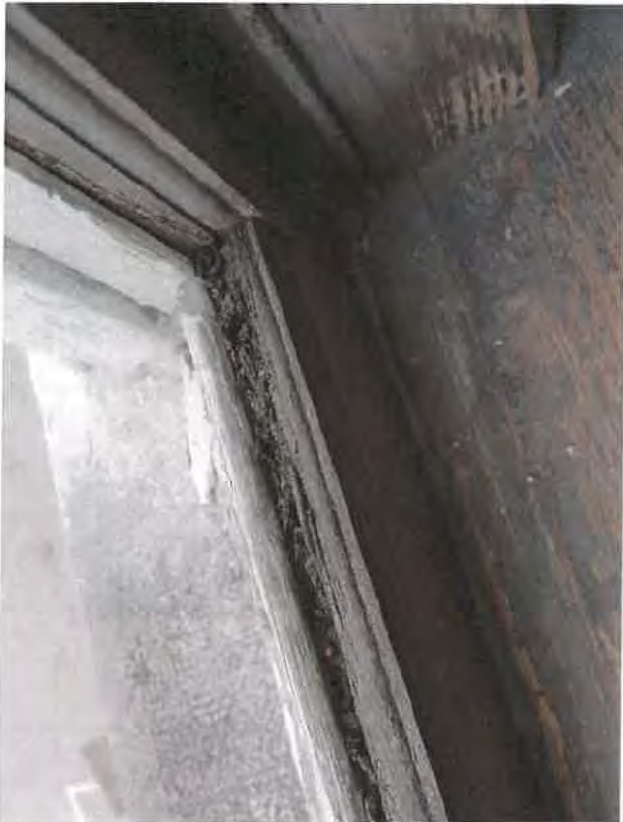
Photo 13: Detail of rotting bottom rail of bottom sash. Note deteriorated finish on interior stool and jamb.

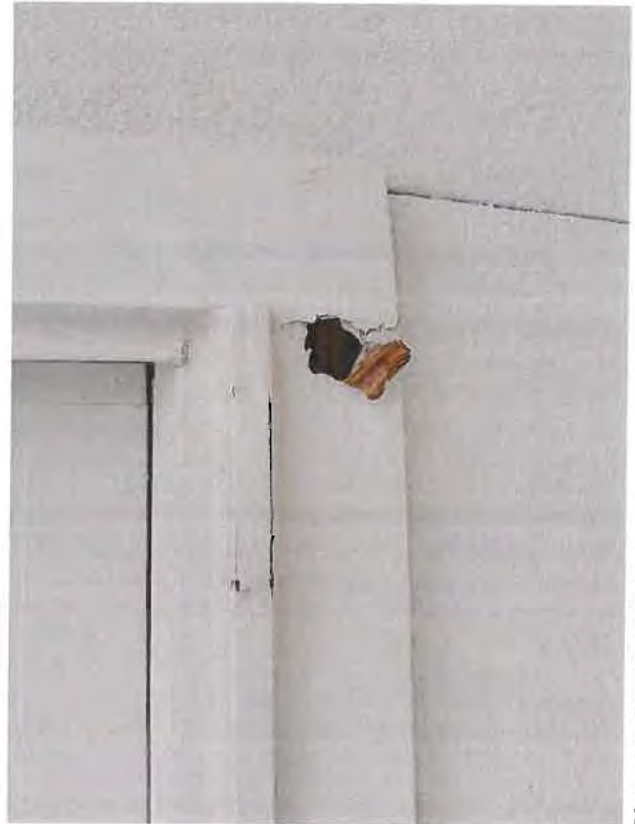
Photo 15: Rotting window trim.

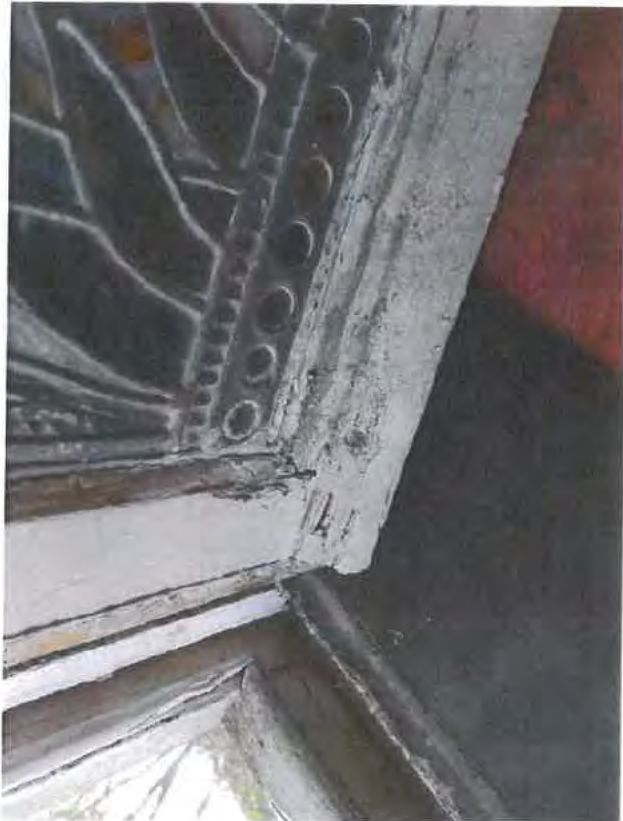
Photo 17: Typical condition of casement sash with stained glass. Note failing glazing putty and deteriorating stile/rail joint.

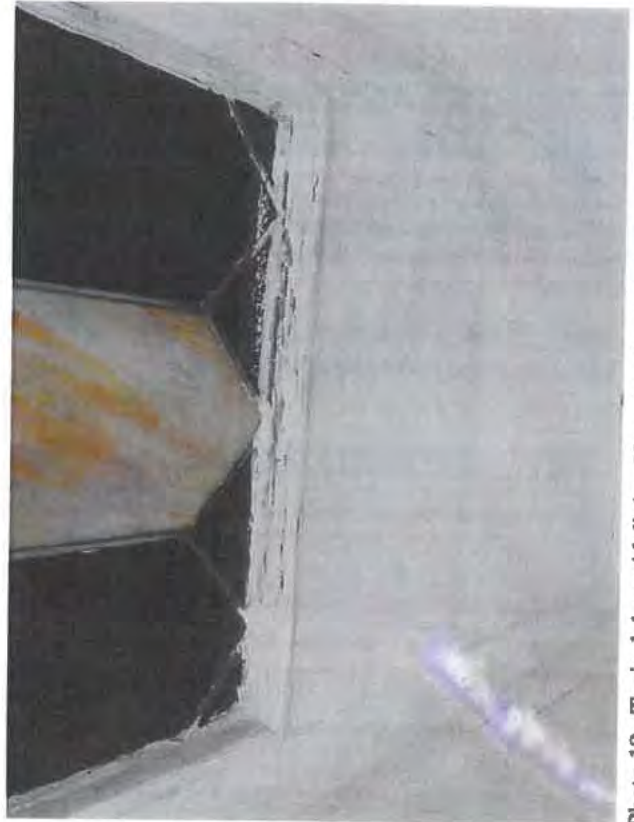
Photo 19: Typical door sidelight. Note deteriorated glass stop, peeling paint, checked wood, and water stains. Glass does not meet safety glazing requirements of the building code.

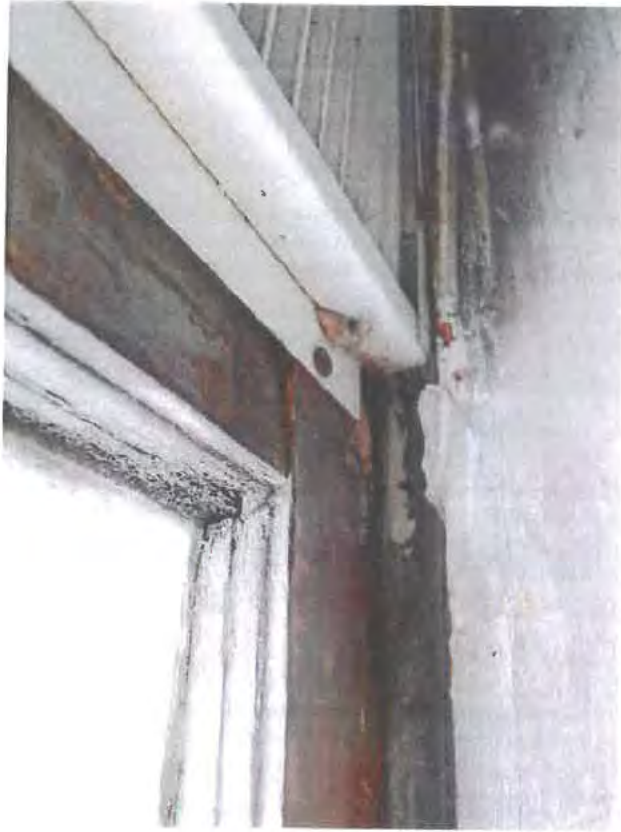
Photo 18: Typical damage caused by window air conditioning units. Note displacement of sash. This air conditioning unit is held in place only by the window sash. The bottom rail of the sash is rotting due to failed putty.

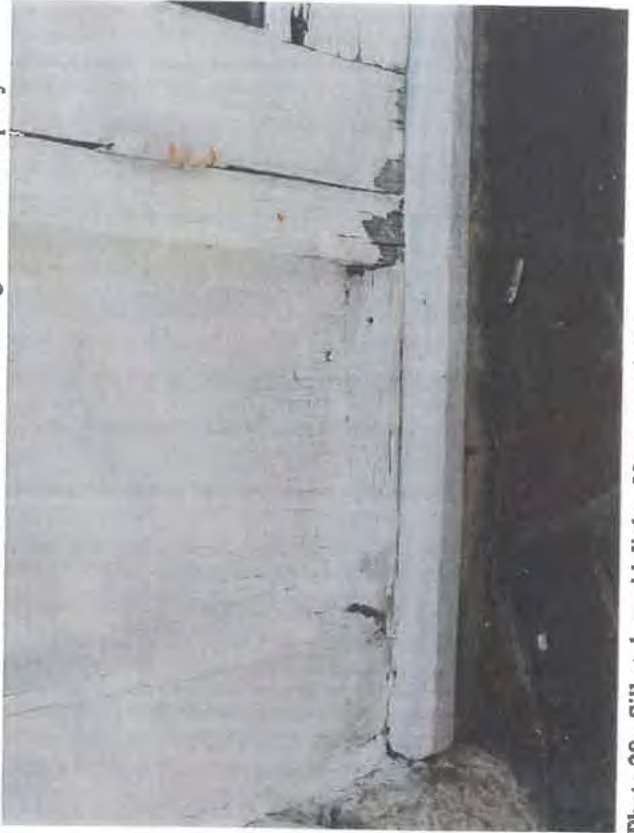
Photo 20: Sill at door sidelight. Note open joints, peeling paint, checked and rotting wood, and rust stains from corroding metal.

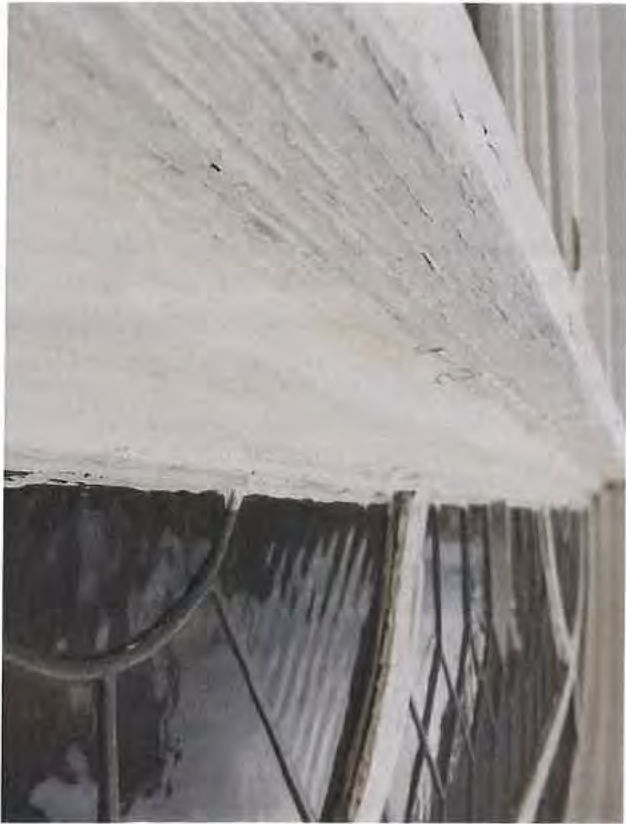
Photo 21: Typical door transom sill condition. Note failing paint, checked wood, and deteriorated glazing putty at glass.

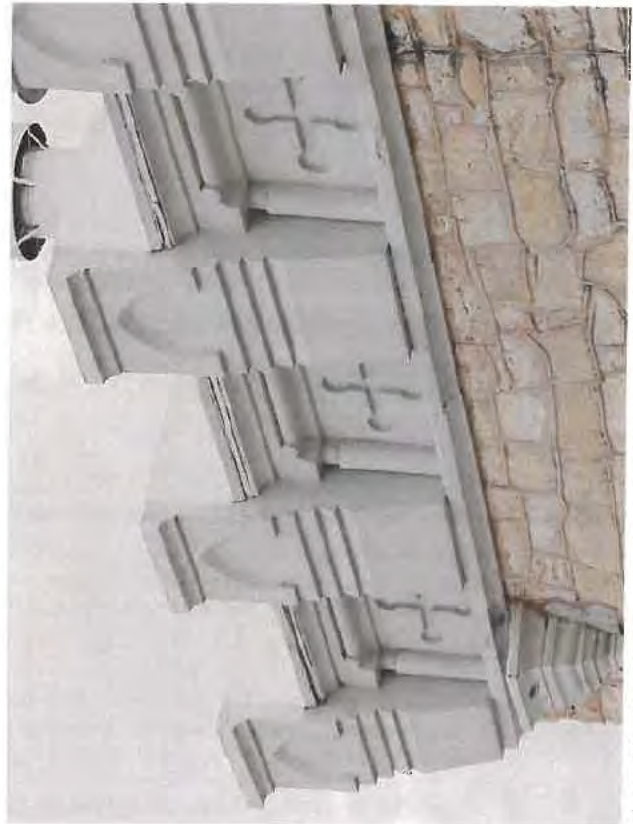
Photo 23: South metal battlement. Note multiple layers of caps, open joints, and deformed metal.

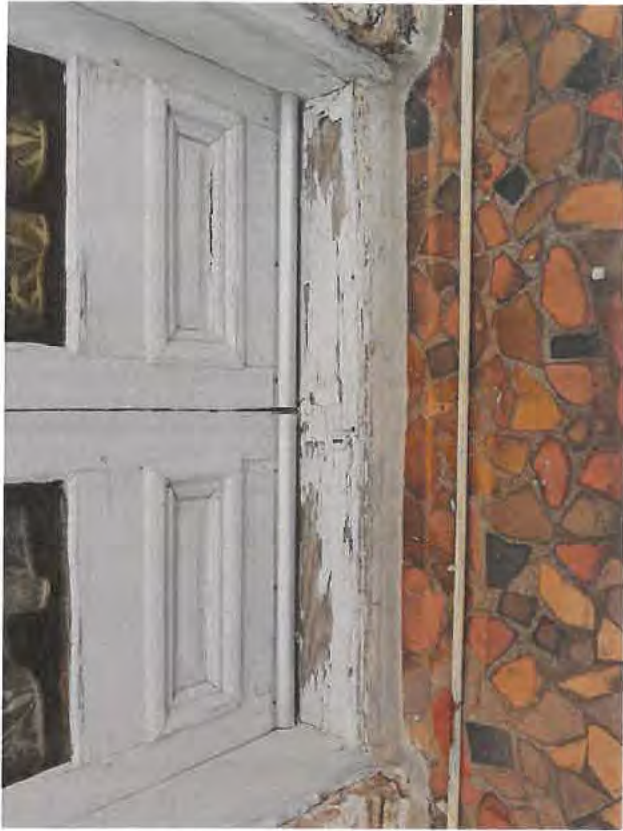
Photo 22: Note peeling paint, exposed wood, and patches on sill. Note failing glazing putty at door glass, open joints in panel moldings and stile/rail joints of doors. Glass does not meet code requirements for safety glazing.

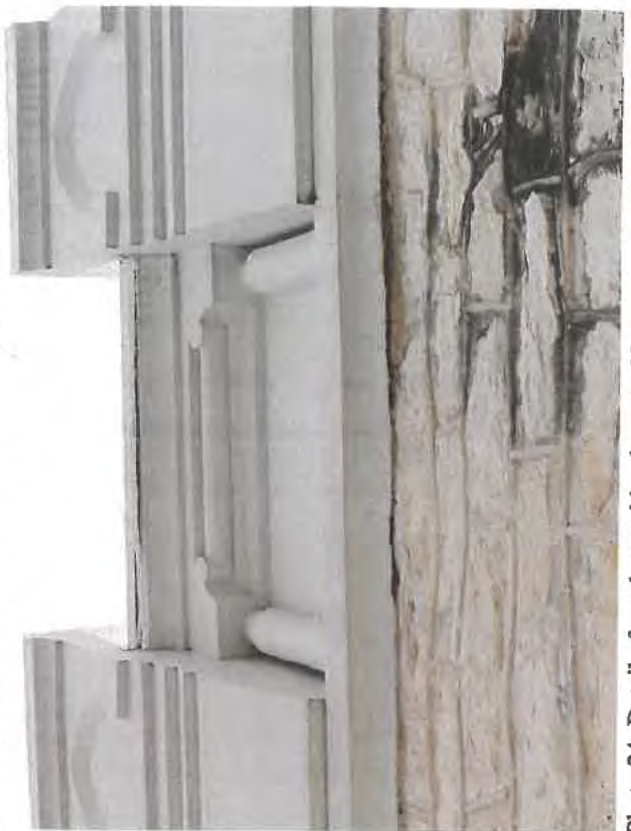
Photo 24: Detail of south metal battlement. Note open metal/stone joint at bottom. Also note algae growth that suggests that water is flowing from battlement.

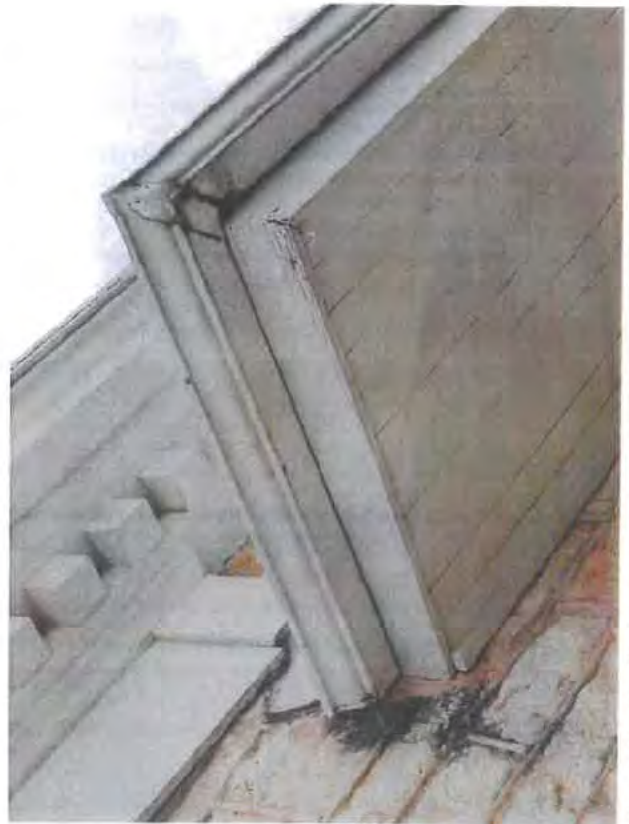
Photo 27: Detail of west end of south balcony roof. Note discoloration at gutter indicating leaks, peeling paint, and open joints.

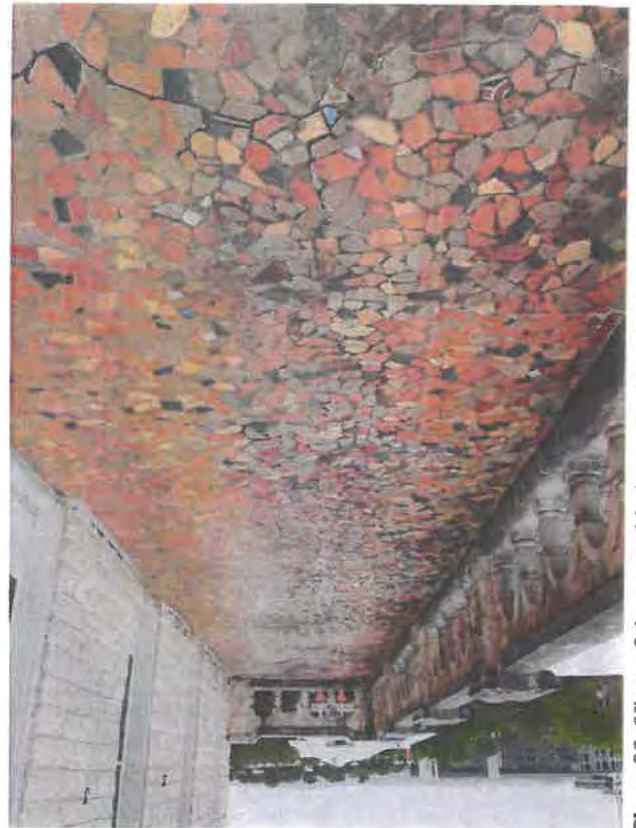
Photo 28: View of the central balcony looking west. Note discoloration that indicated flow of water. Darkest areas are those where water collects.

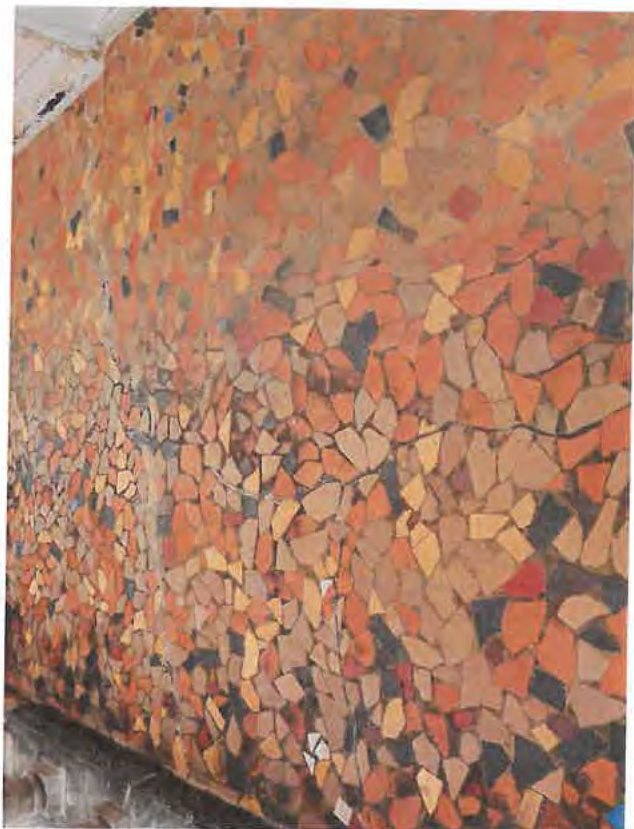
Photo 29: Detail of cracks in central balcony tile deck.

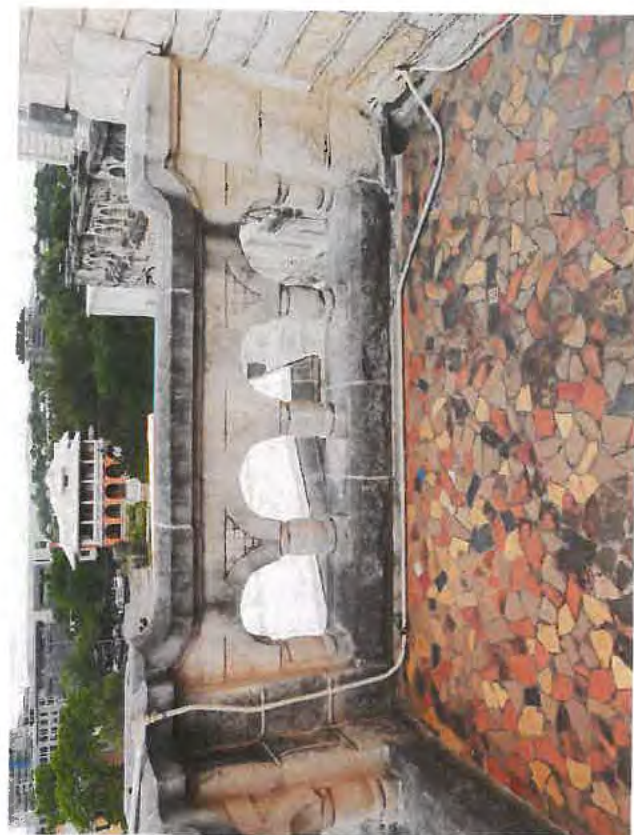
Photo 30: Central balcony is drained through only one scupper at the northwest corner. Note that conduit inhibits drainage.

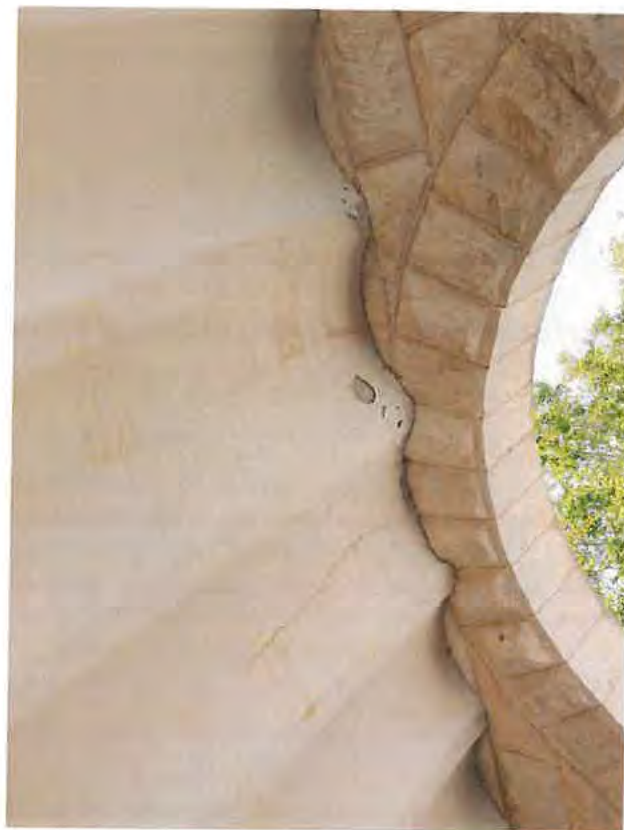
Photo 31: Detail of south portico ceiling showing leaks from cracks in tile deck of central balcony above. The rusty color of the water stains indicates that structural reinforcing is corroding and causing the cracking.

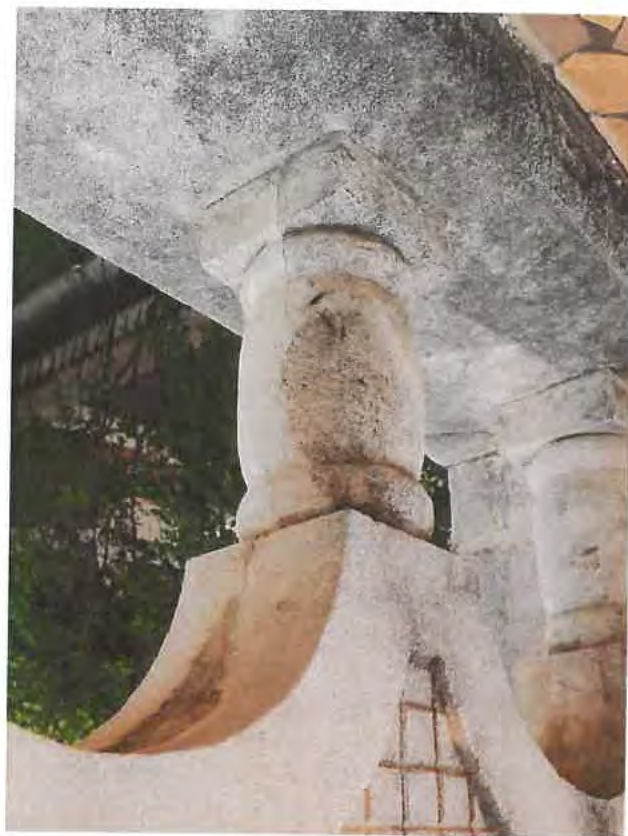
Photo 32: Previously patched balauster at central balcony is cracking.
